# STUDY CASE

## Village of Ndiobène (Louga)

Project Installation of a waterproof System O)) treatment unit in a private residence located in the village of Ndiobène

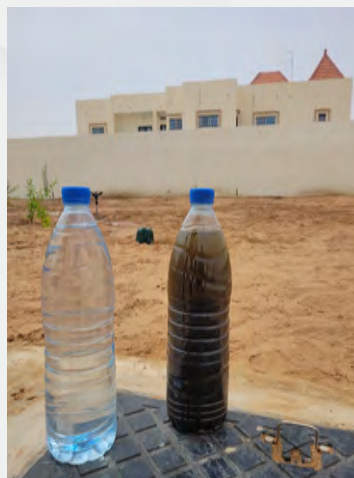
Water quality before and after System O)) treatment

**Purification performance well below the country's standards:**

- Less than 40mg/L of BOD5 (biochemical oxygen demand over oxygen demand)
- Less than 50mg/L of suspended solids (SS)
- Less than 2000 CFU/100ml of fecal coliforms

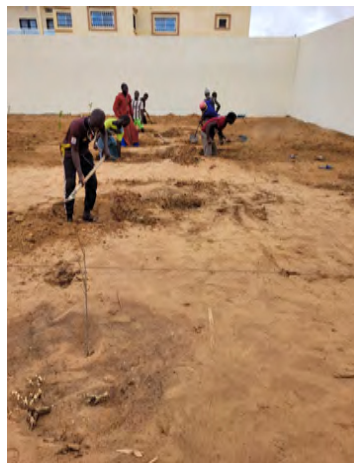
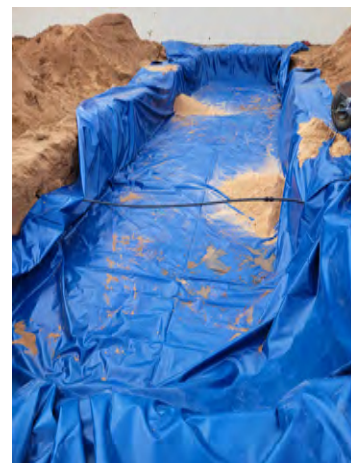
The System O)) installation is preceded by a primary treatment. The untreated wastewater is collected in 2 septic tanks. Inside these tanks, it is divided into layers with the fat rising to the surface and the solids falling to the bottom. At the exit of the septic tanks, the wastewater flows towards the System O)) in a gravitational way following a natural slope.

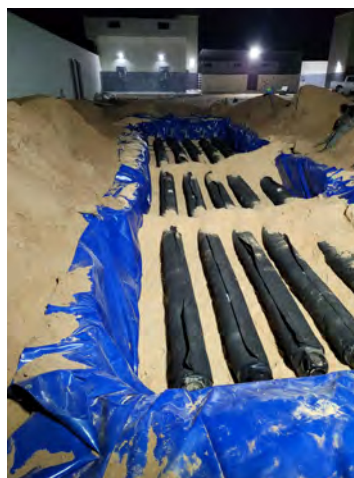
The installation is composed of a cell of 5 rows of Advanced Enviro))Septic pipes.

The wastewater leaves the septic tank and lands gravitationally in the distribution box which distributes it equally among the 5 rows of pipes. The optimal operation of a System O)) installation depends on an even distribution of the wastewater through the rows of pipes.

This is achieved through equalizers that are installed inside the distribution boxes. They have indentations that are manually adjusted during installation and do not need to be adjusted afterwards. They are the only parts that can move in the entire system. The pipes have a 20 year warranty.

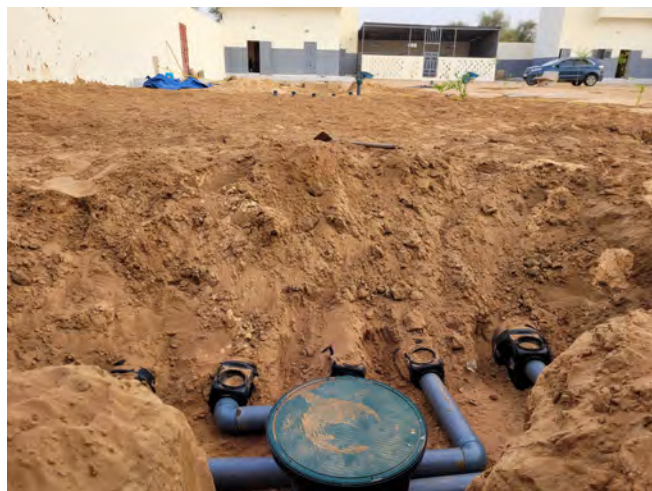
System O)) distribution box

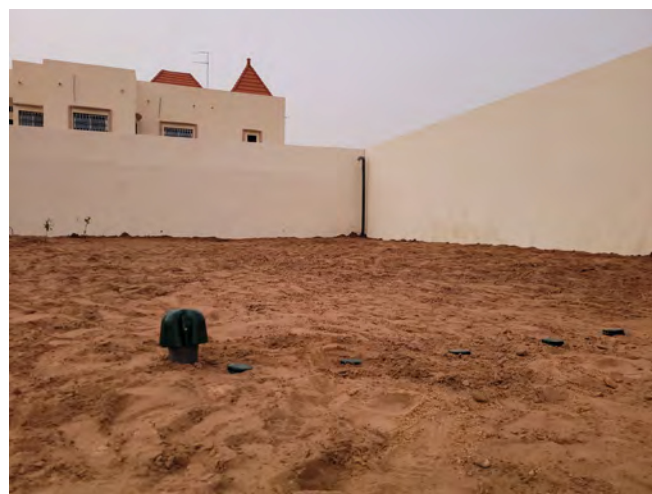
Completed System O)) installation

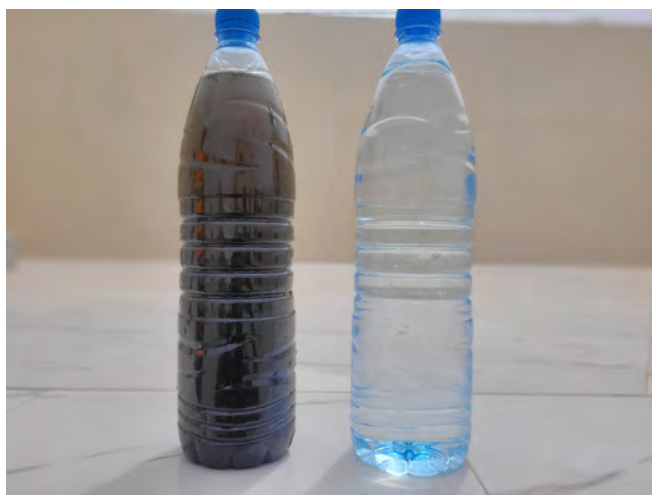
Visual quality of the water at the entrance and exit of the system
