# REFERENCE

## Village of Ndiobène (Louga)

Project Installation of a waterproof System O)) treatment unit in a private residence located in the village of Ndiobène

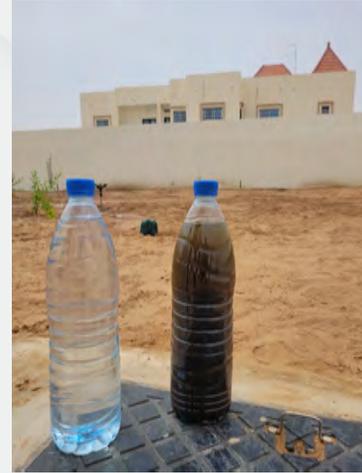
Water quality before and after System O)) treatment

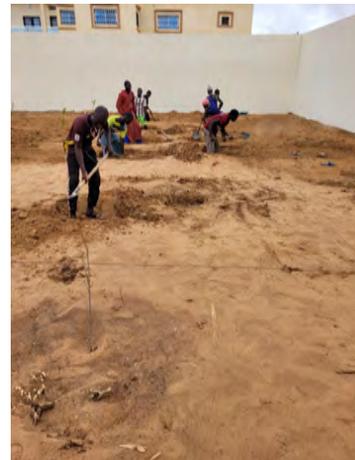
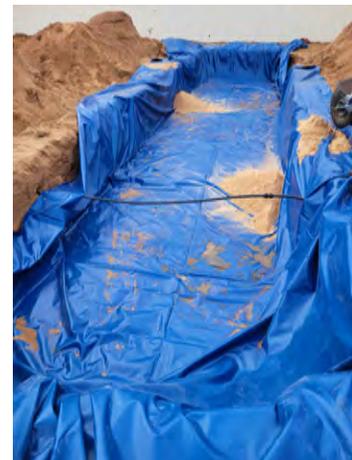
The System O)) installation is preceded by a primary treatment. The untreated wastewater is collected in 2 septic tanks. Inside these tanks, it is divided into layers with the fat rising to the surface and the solids falling to the bottom. At the exit of the septic tanks, the wastewater flows towards the System O)) in a gravitational way following a natural slope.

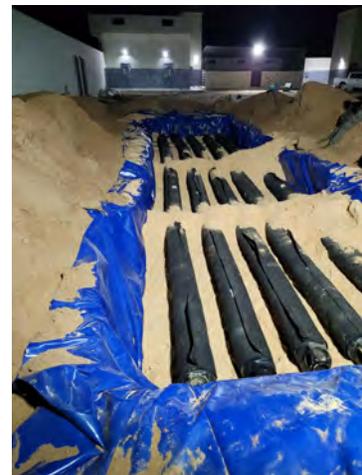
The installation is composed of a cell of 5 rows of 4 pipes for a total of 20 pipes distributed on 1 level.

The wastewater leaves the septic tank and lands gravitationally in the distribution box which distributes it equally among the 5 rows of pipes. The optimal operation of a System O)) installation depends on an even distribution of the wastewater through the rows of pipes.

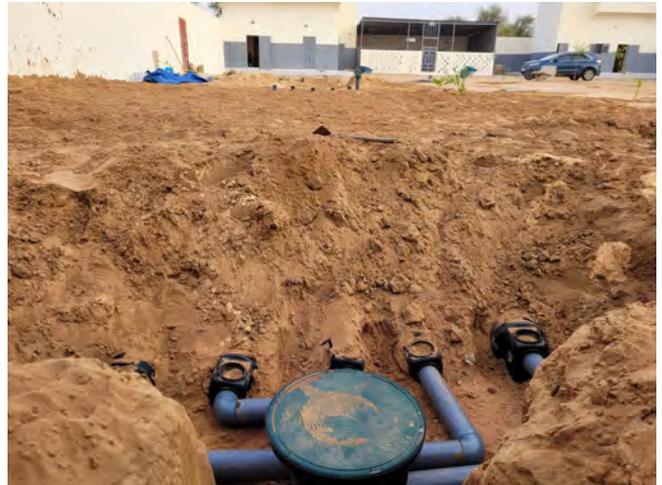
System O)) distribution box

This is achieved through equalizers that are installed inside the distribution boxes. They have indentations that are manually adjusted during installation and do not need to be adjusted afterwards. They are the only parts that can move in the entire system. The pipes have a 20 year warranty.

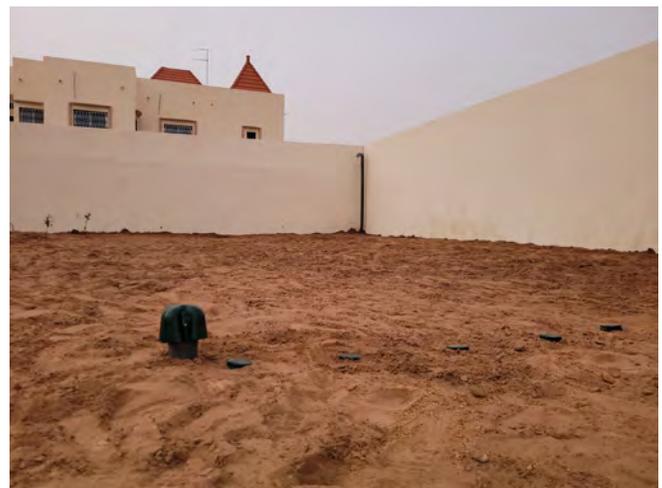
Completed System O)) installation

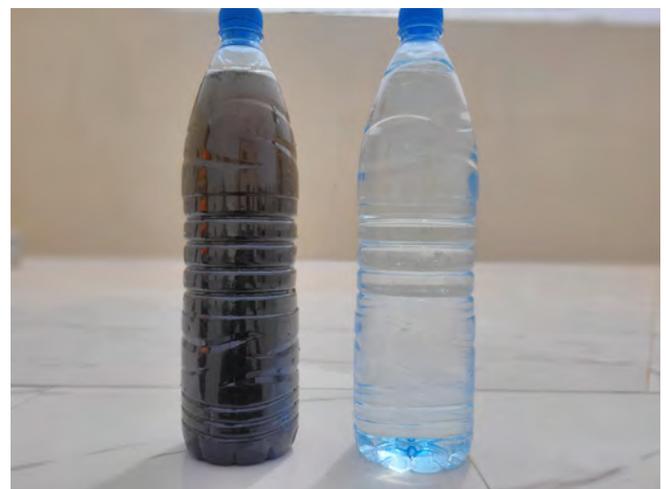
Visual quality of the water at the entrance and exit of the system
